Holderness Erosion and Evolution of the Spurn Peninsula

**Prof. Ken Pye
and Dr. Simon Blott**

Kenneth Pye Associates Ltd.

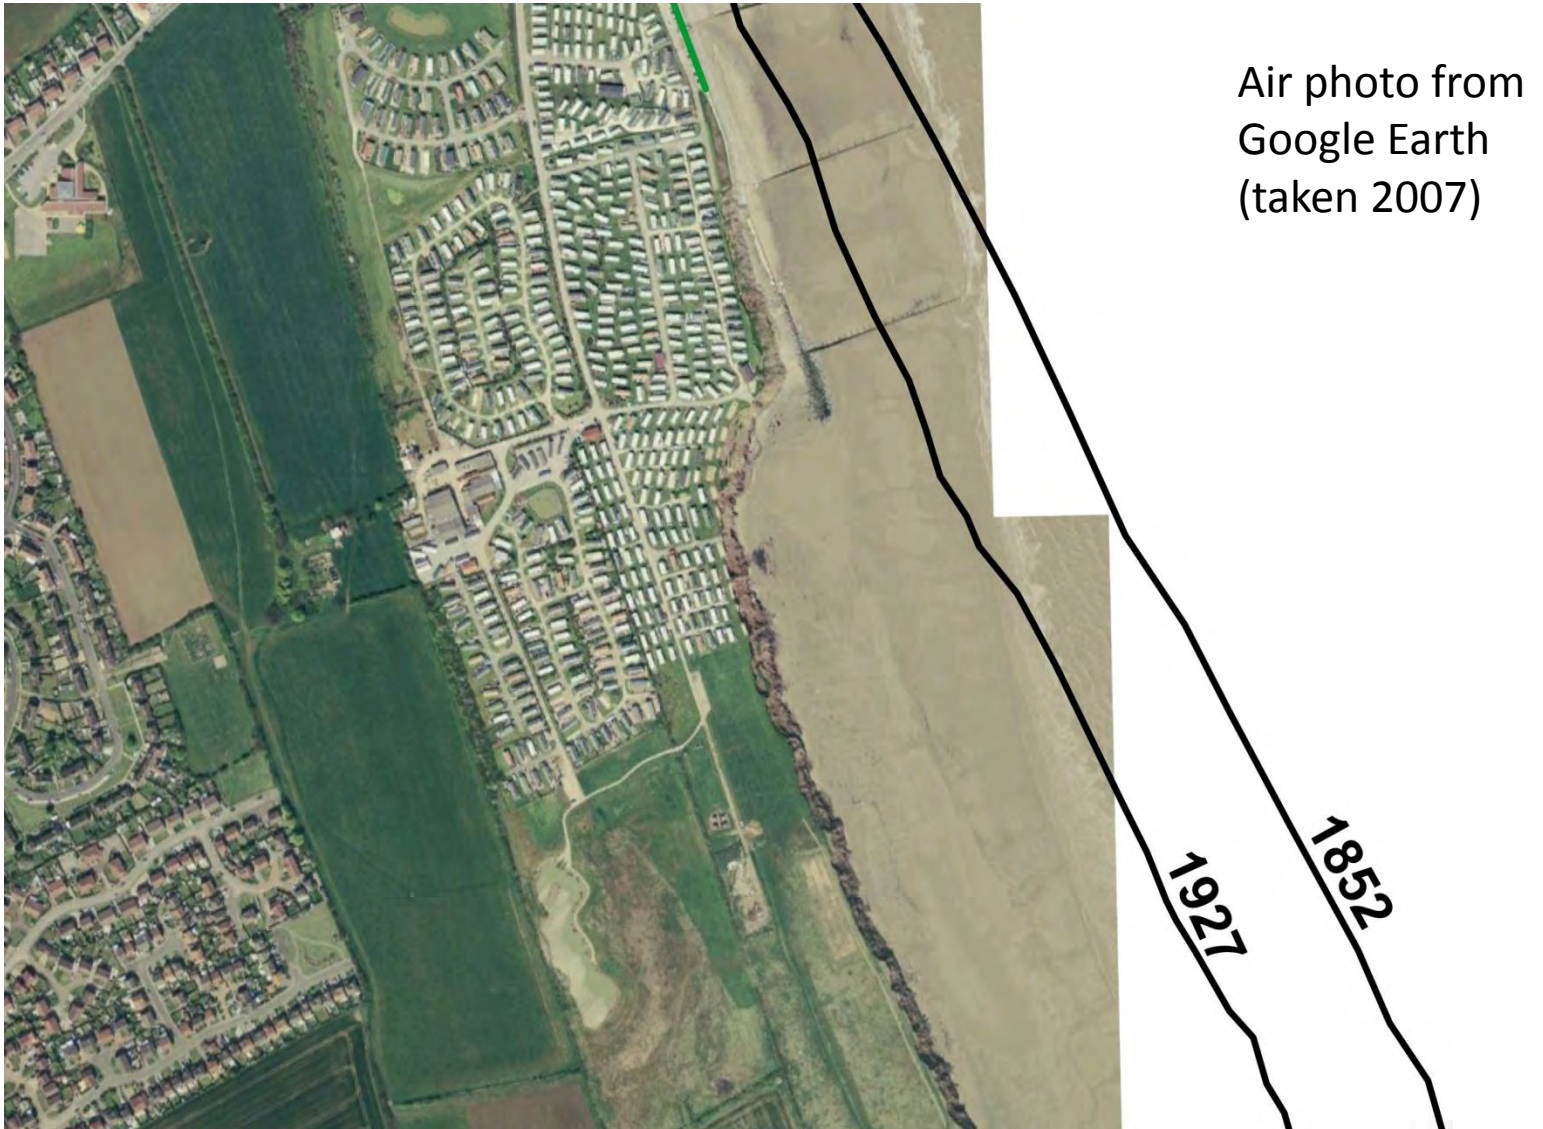
Air photograph of the southern end of Hornsea frontage, with cliff toe positions from OS maps

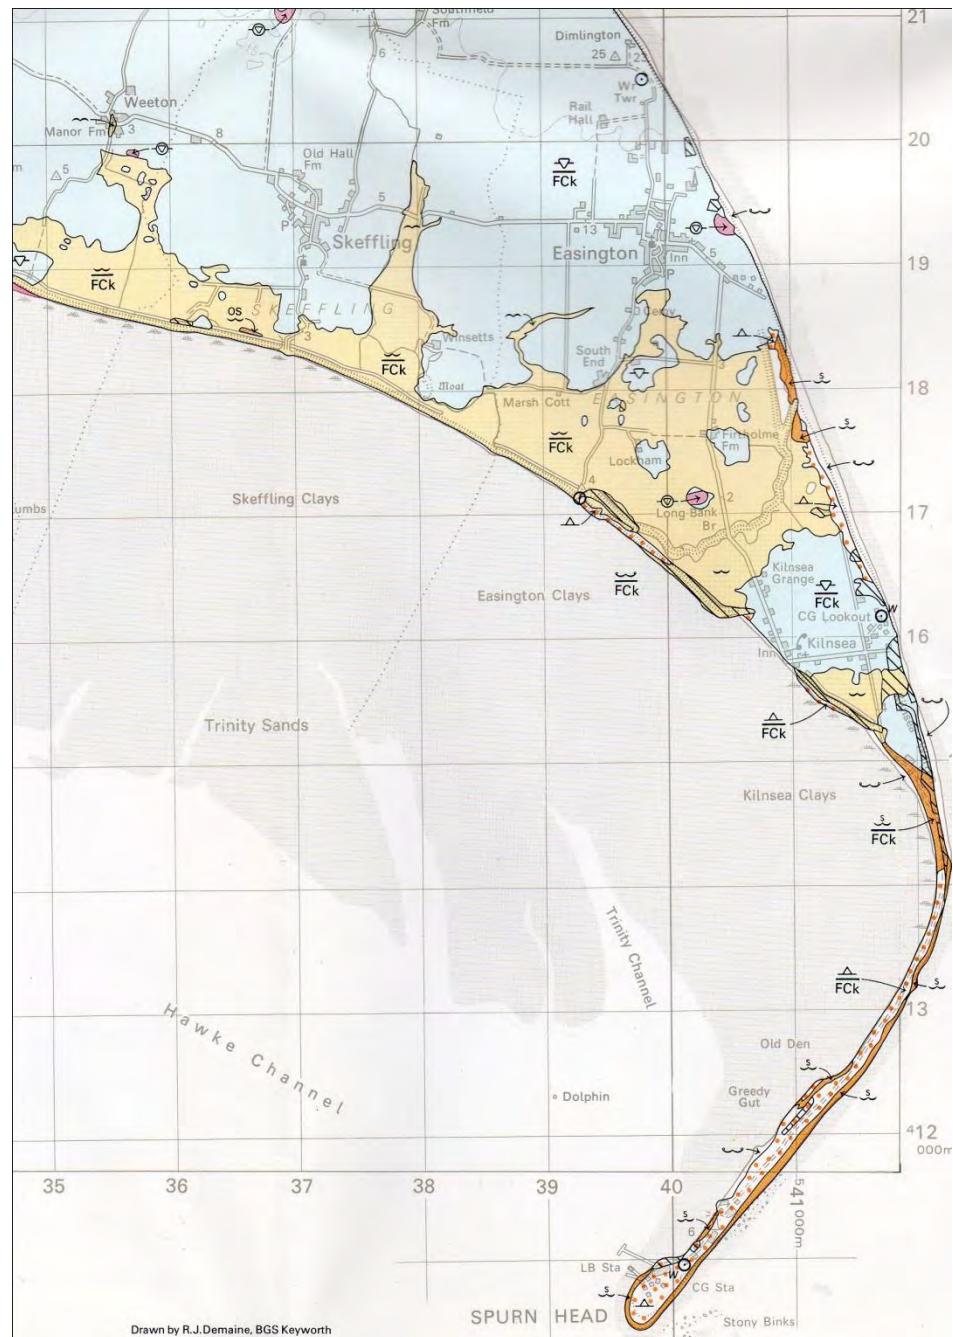
Superficial geology map of the Kilnsea and Spurn area

BGS 1:50,000 scale survey.

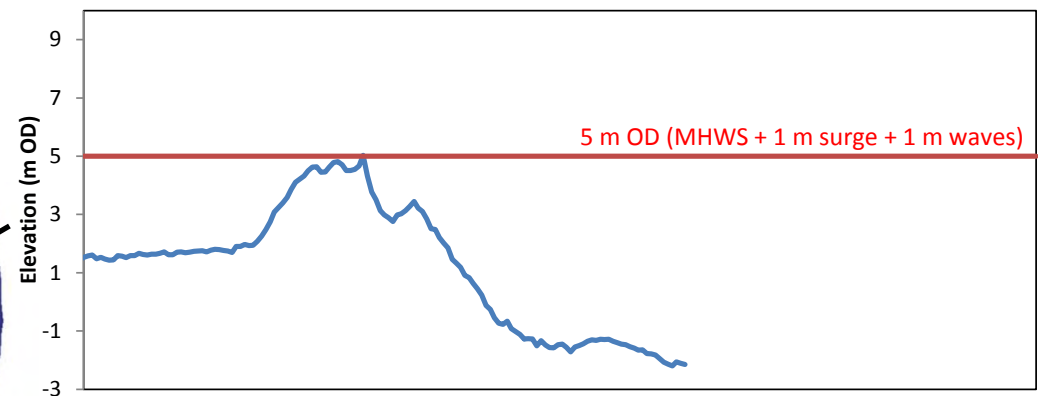
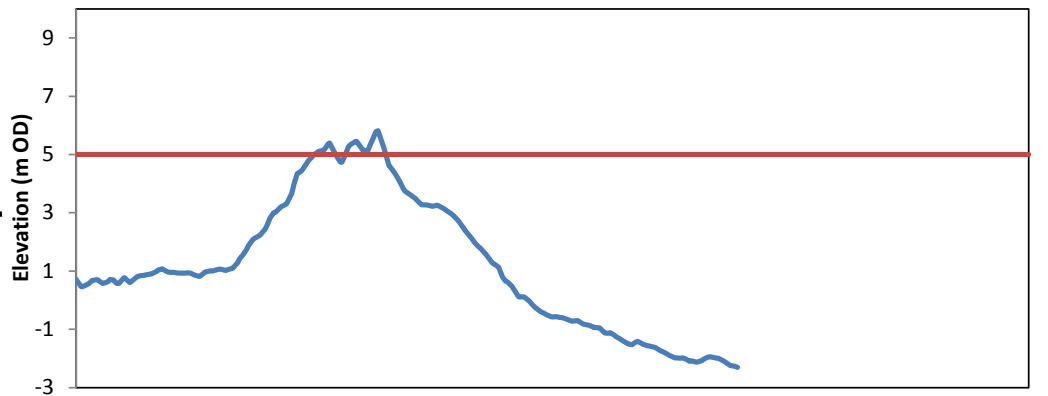
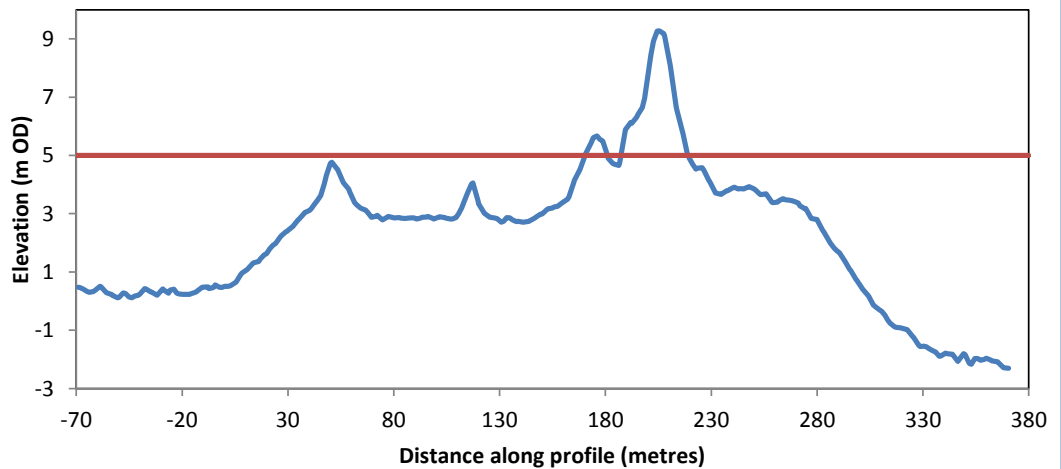
**Cross-sectional profiles
across Spurn
(LiDAR data flown 1999)**

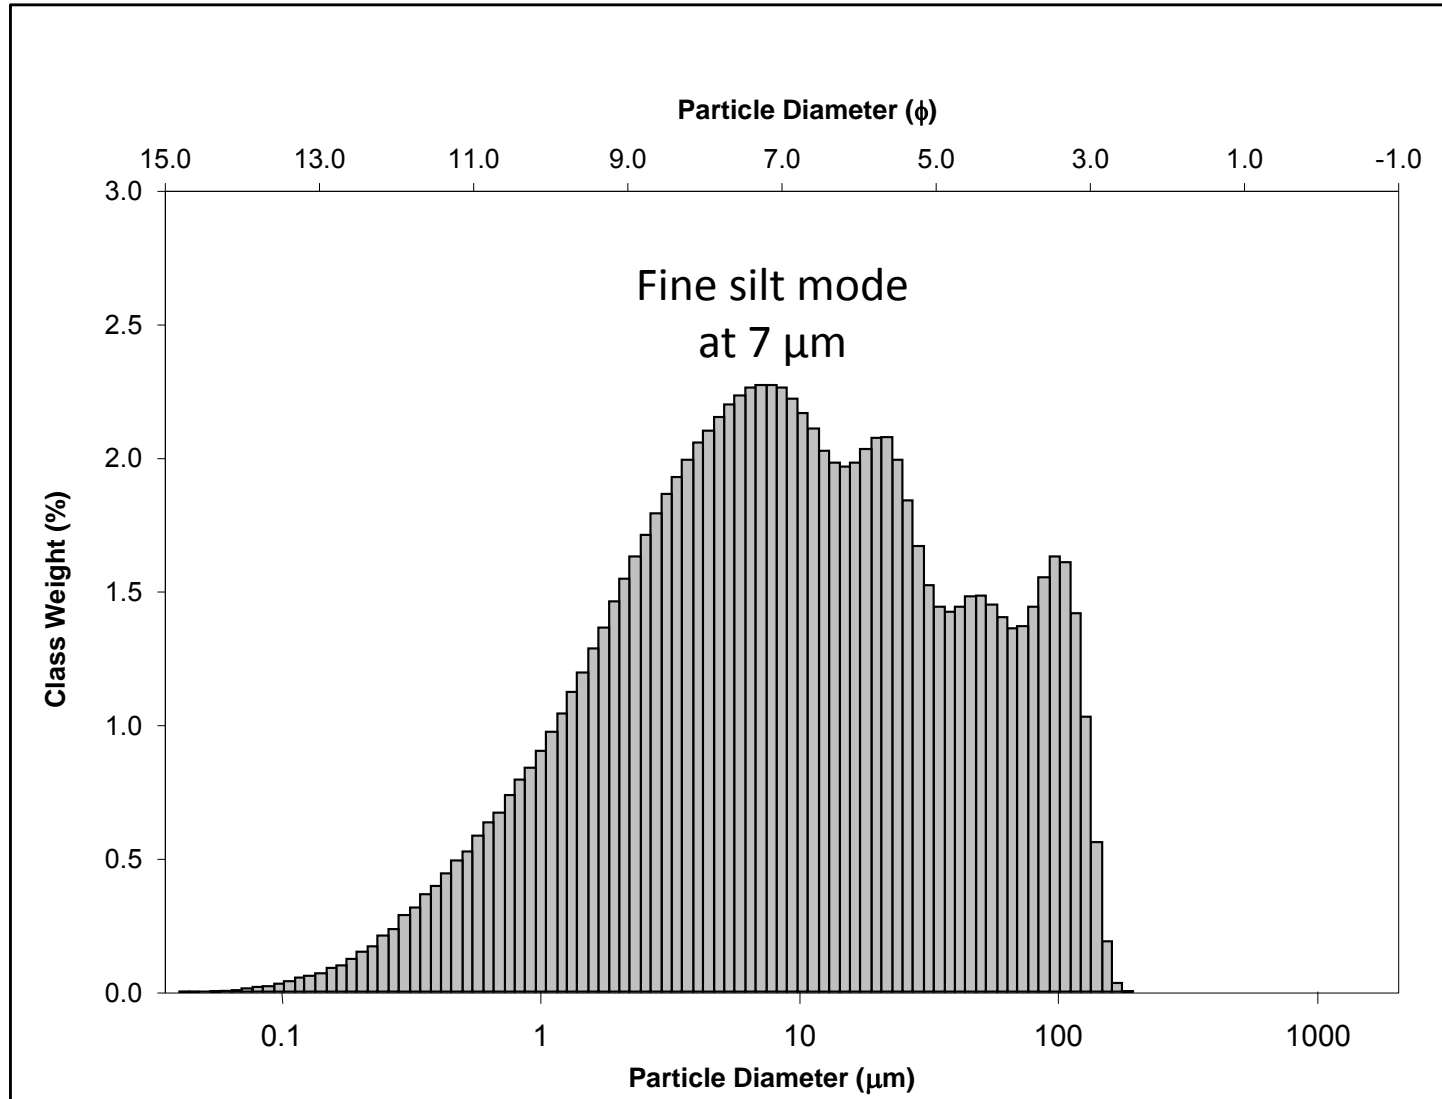
Particle size histogram for sediment collected from the till cliff at Ringbrough Farm, near Aldbrough

- Over the entire 52 km of the Holderness coastline, 153 million cubic metres of sediment has been eroded since 1852
- The till cliffs are largely composed of mud and fine sand, and as a consequence <10% of the sediment is retained in the beach/nearshore system to provide protection from future erosion
- The coastline is subjected to a strong tidal and wave-induced southerly littoral drift. This is unlikely to change in the future.
- Defended sections of coast at Bridlington, Hornsea, Withernsea and Easington will continue to act as hard points, which locally continue to reduce rates of erosion.

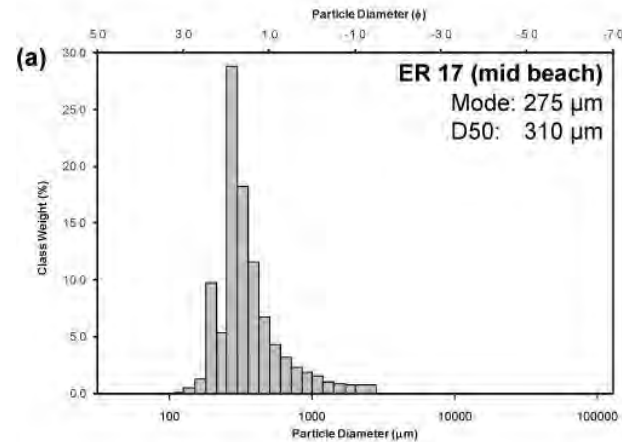
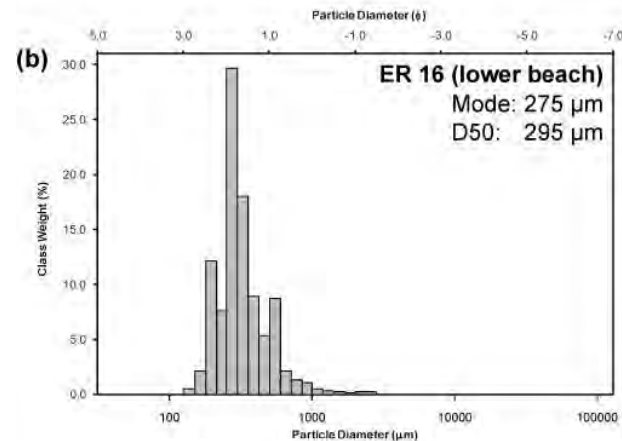
Particle size histograms for sediment samples collected at three cross- shore positions at Aldbrough

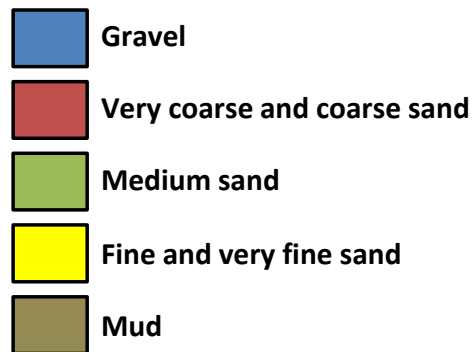
Comparison of percentages of gravel, sand and mud in cliff, beach and dune sediments along the Holderness coast and Spurn Peninsula
